The report consists of a sketch
[redacted] and a sketch of

~~Port of Veracruz~~

Legend for Appendix No. 1

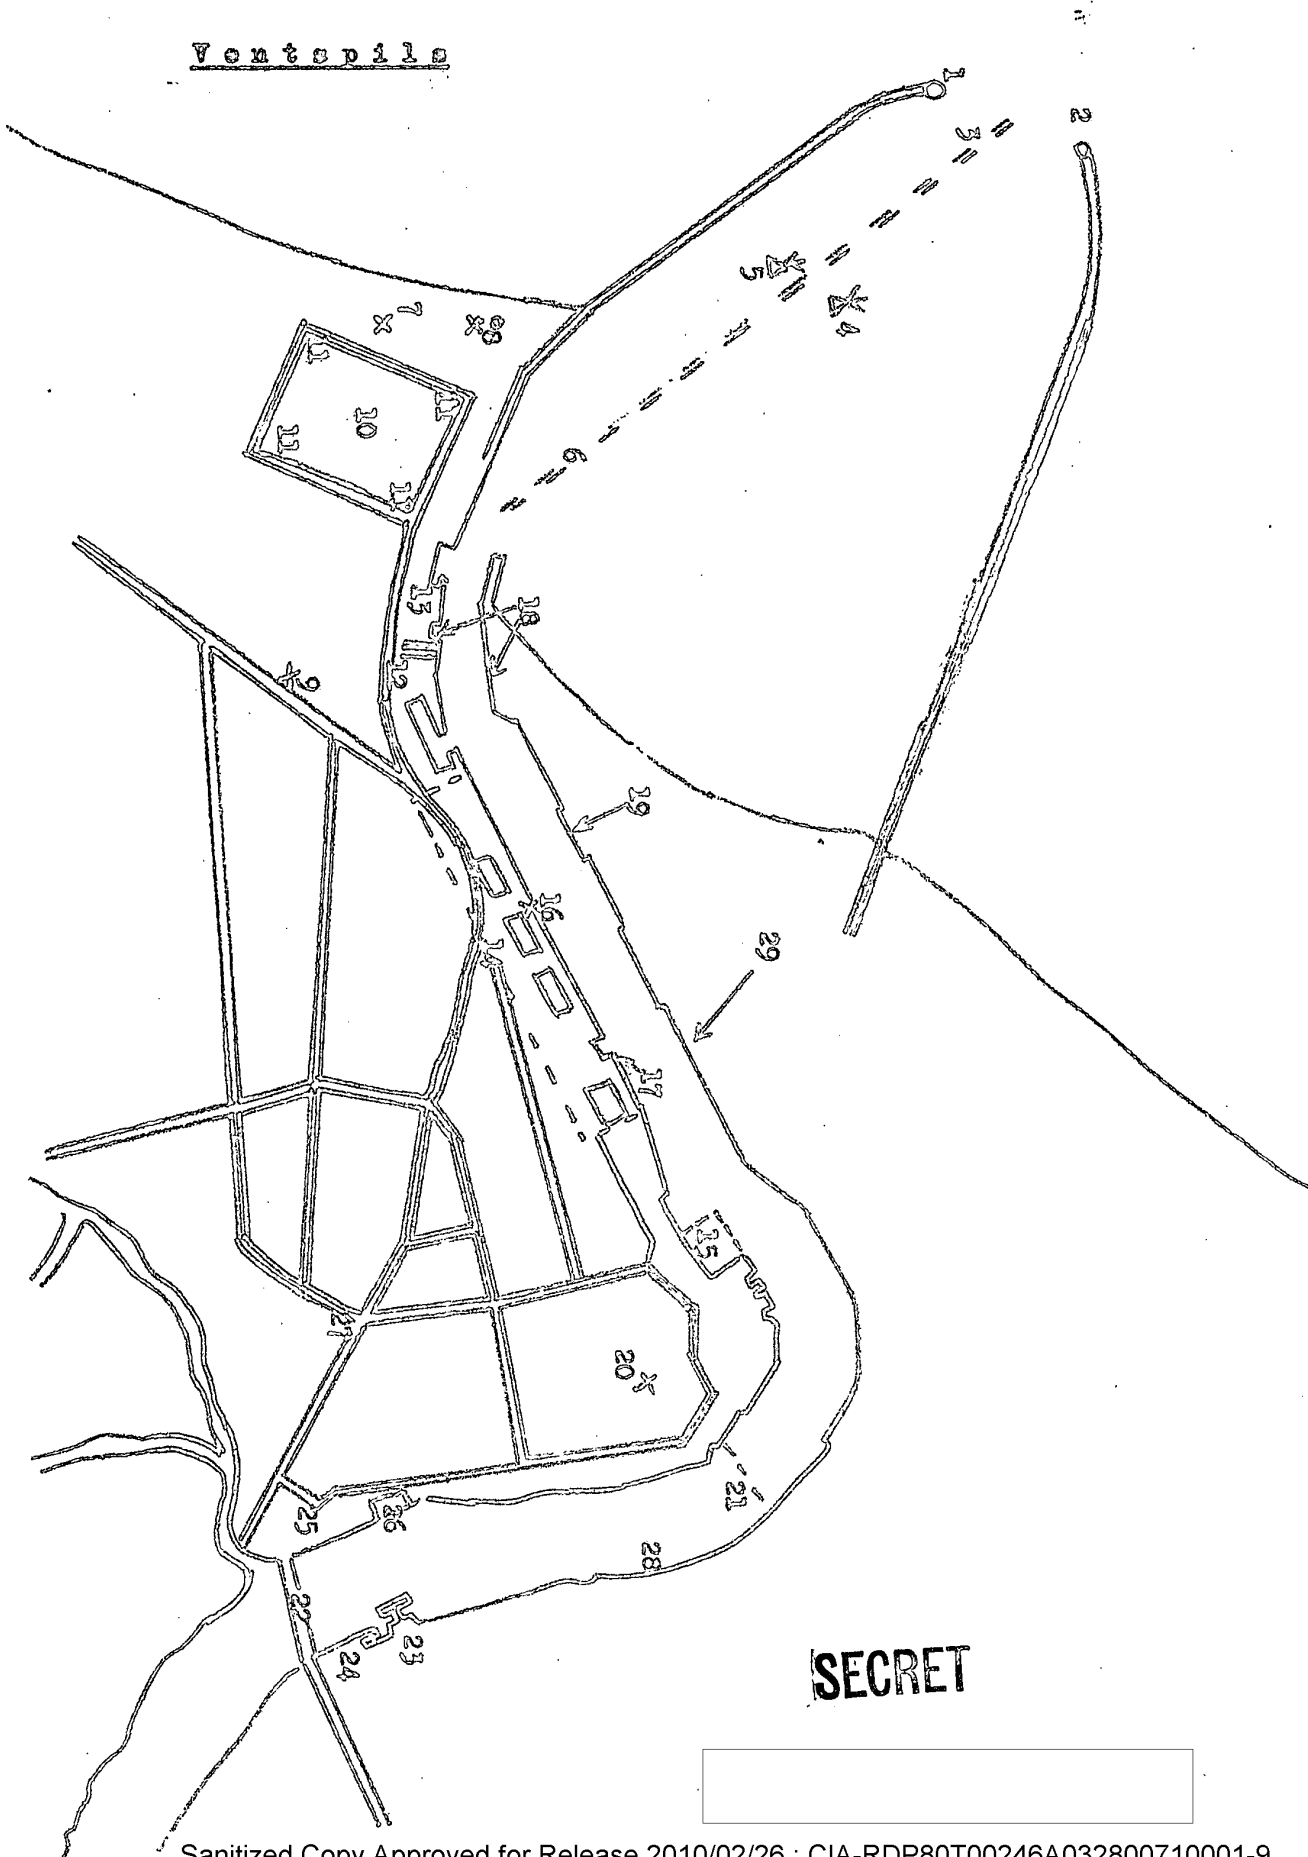
1. Beacon on the southern breakwater.
2. Beacon on the northern breakwater.
3. Dredger working in this area.
4. Approximate position of green buoy.
5. Approximate position of red buoy.

6. Dredger working in this area.
7. Pilot station.
8. Searchlight tower. Observed at 60 nautical miles. All searchlights along the coast were coordinated, and when one was turned on it was right on the objective. They scanned the sea at intervals of two hours.

9. Lantern on a cement tower.
10. Fenced-in area.
11. Guard and searchlight towers for fenced-in area. Guards had automatic weapons.
12. Slip for small shipyard. Vessels are dragged up into a shed with a big opening.

13. Area for fitting-out fishing vessels.
14. Naval depot.
15. Mooring area for target floats. Fabric with radar reflectors.
16. Quay with wooden pilings.

17. Quay with wooden pilings, in poor condition.
18. Sloping shore with pilings.
19. Old quay with pilings.
20. Church steeple in a desolate area.
21. Ferry.

22. Pontoon bridge in very poor condition. pontoons are square-edged, decked barges of wood. Loaded trucks caused the bridge to oscillate when crossed at 5-10km/hr.

23. Oil pier for tankers over 6,000 GRT. The pier is T-shaped.
24. Docking area for vessels.
25. Workshop for the repair and building of pontoons for the bridge.

26. Coal supply, without quay.
27. Radio antennae.
28. Quay area
29. Modernly equipped quay.

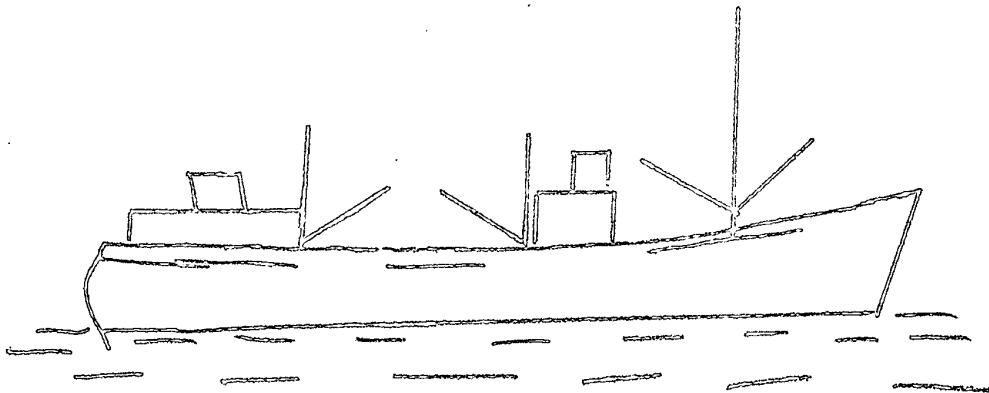
Appendix 3

Four similar merchant vessels of about 1,000 GRT each lay north of the bridge abutment. (See Appendix No. 3).
